# COMBINED PRELIMINARY ASSESSMENT/SITE INSPECTION REPORT

Former Hulett Lagoon Site Camdenton, Missouri

March 30, 1999

Missouri Department of Natural Resources Division of Environmental Quality Hazardous Waste Program

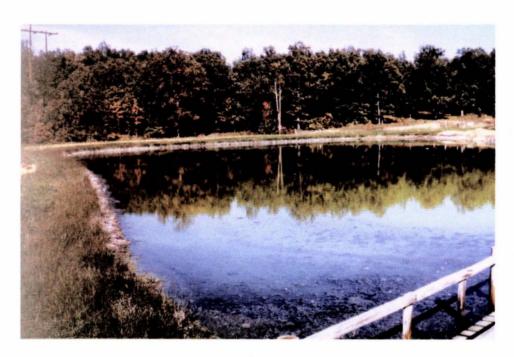
**PHOTO 1**

Former Hulett Lagoon Site. Camdenton, MO, Camden County. Photo taken on 10/1/74 by Ronnie Testerman, MDNR, JCRO. View looking northeast at the Hulett lagoon during operation. The northern portion of the lagoon shown in the photo was where influent from domestic sewage entered the lagoon. A small amount of the sludge from the Sundstrand influent, which came in on the south portion of the lagoon can be seen in the foreground of the photo near the wooden catwalk.

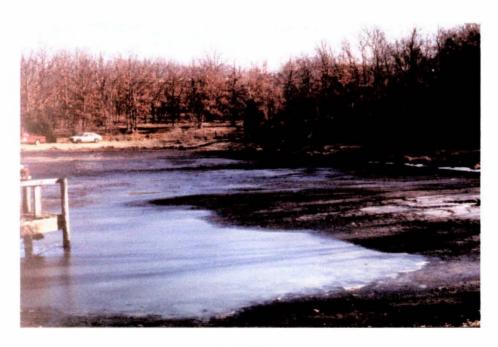
**PHOTO 3**

Former Hulett Lagoon Site. Camdenton, MO, Camden County. Photo taken sometime in June or July 1989 by Ronnie Testerman, MDNR, JCRO. View looking northeast at the Hulett lagoon during the beginning of the closure process. The dewatering had begun, but no sludge had been removed.

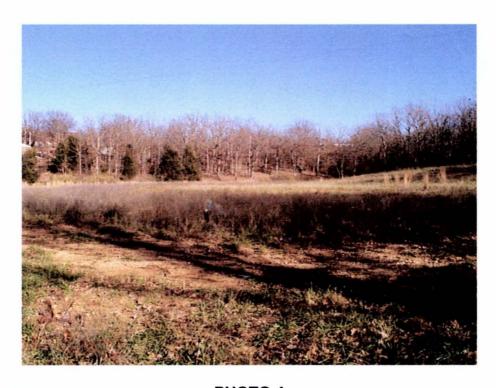
**PHOTO 4**

Former Hulett Lagoon Site. Camdenton, MO, Camden County. Photo taken on 12/1/98 by Valerie Wilder, MDNR, Superfund. View looking northeast at the former lagoon. Remnants of the road that was around the lagoon on its berm can be seen in the foreground.

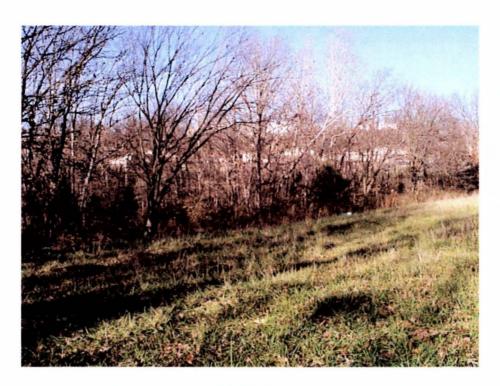
**PHOTO 5**

Former Hulett Lagoon Site. Camdenton, MO, Camden County. Photo taken on 12/1/98 by Valerie Wilder, MDNR, Superfund. Photo taken looking north at the hillside west of the lagoon. The apartment complex buildings north of the lagoon can be seen through the trees.

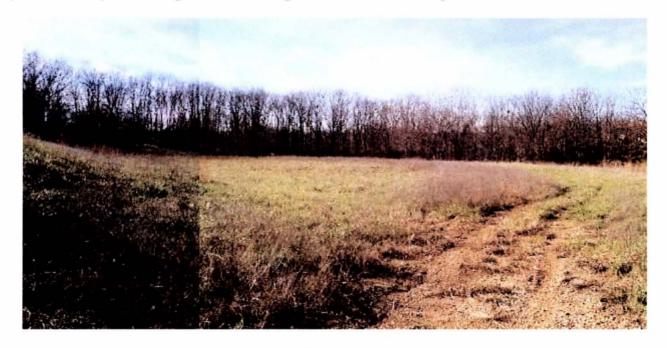
### **PHOTO 6**

Access is not restricted to the site; there is no fencing. The gravel access road from West Mulberry is not maintained; there are several severe ruts caused from washouts. There have been reports that illegal dumping is occurring on Ron Hulett property along the north and south side of the access road. There were a few pieces of trash in the lagoon area (Reference 5).

Former Hulett Lagoon Site. Camdenton, MO, Camden County. Photo taken on 12/1/98 by Valerie Wilder, MDNR, Superfund. Photo taken looking south-southeast. The road surrounding the lagoon on the berm is seen in the right-hand side of the photo. The former lagoon was in the area in the left-hand side of the photo.

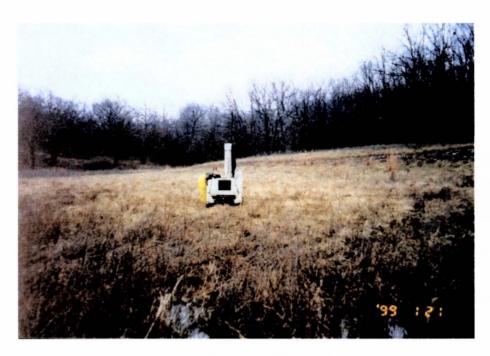
**PHOTO 7**

Former Hulett Lagoon Site. Camdenton, MO, Camden County. Photo taken on 1/21/99 by Valerie Wilder, MDNR, Superfund. Photo taken looking northeast at Geoprobe work during PA/SI sampling.

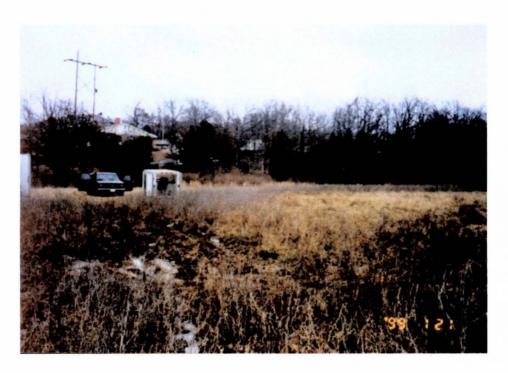
**PHOTO 8**

Former Hulett Lagoon Site. Camdenton, MO, Camden County. Photo taken on 1/21/99 by Valerie Wilder, MDNR, Superfund. Photo taken looking north-northeast at Geoprobe work during PA/SI sampling. The apartment complex north of the lagoon can be seen through the trees.
